CULTURAL LANDSCAPE REPORT
FOR THE SANDY HOOK
COASTAL DEFENSE BATTERIES
GATEWAY NATIONAL RECREATION AREA

CULTURAL LANDSCAPE REPORT FOR THE SANDY HOOK COASTAL DEFENSE BATTERIES

GATEWAY NATIONAL RECREATION AREA

FORT HANCOCK, NEW JERSEY

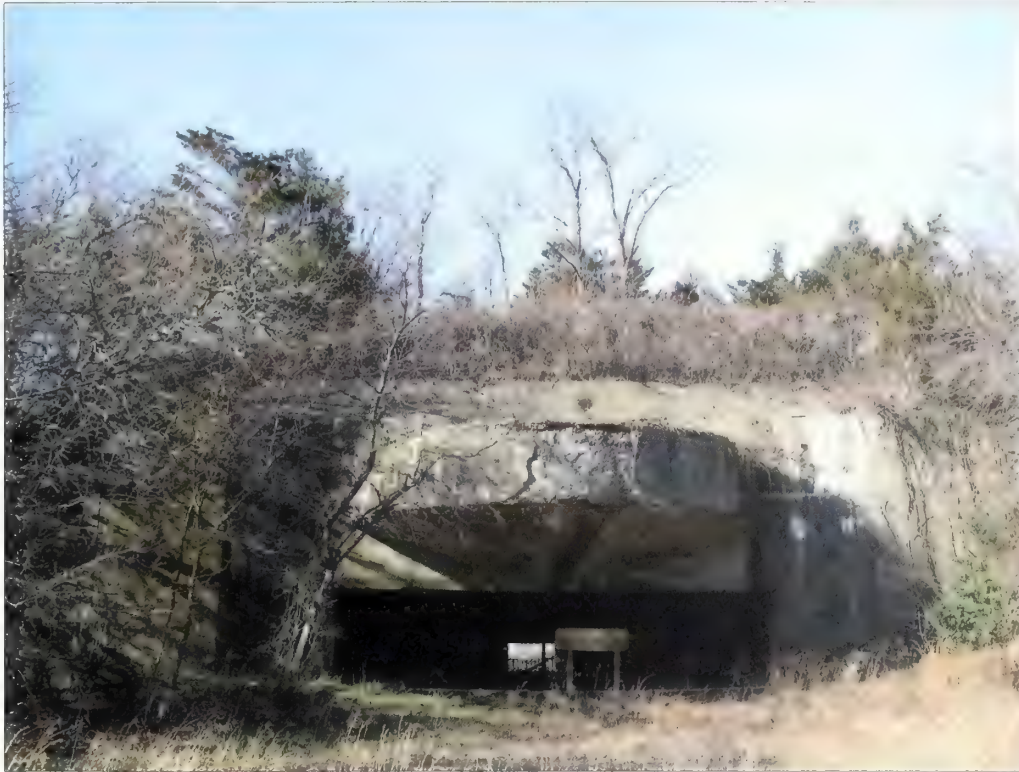
Figure 3.49. View looking west at emplacement #2, Battery Mills. Above the emplacement, large spalling areas on the concrete canopy result from infiltration of water and seasonal freezing and thawing (Olmsted Center, January 2009).

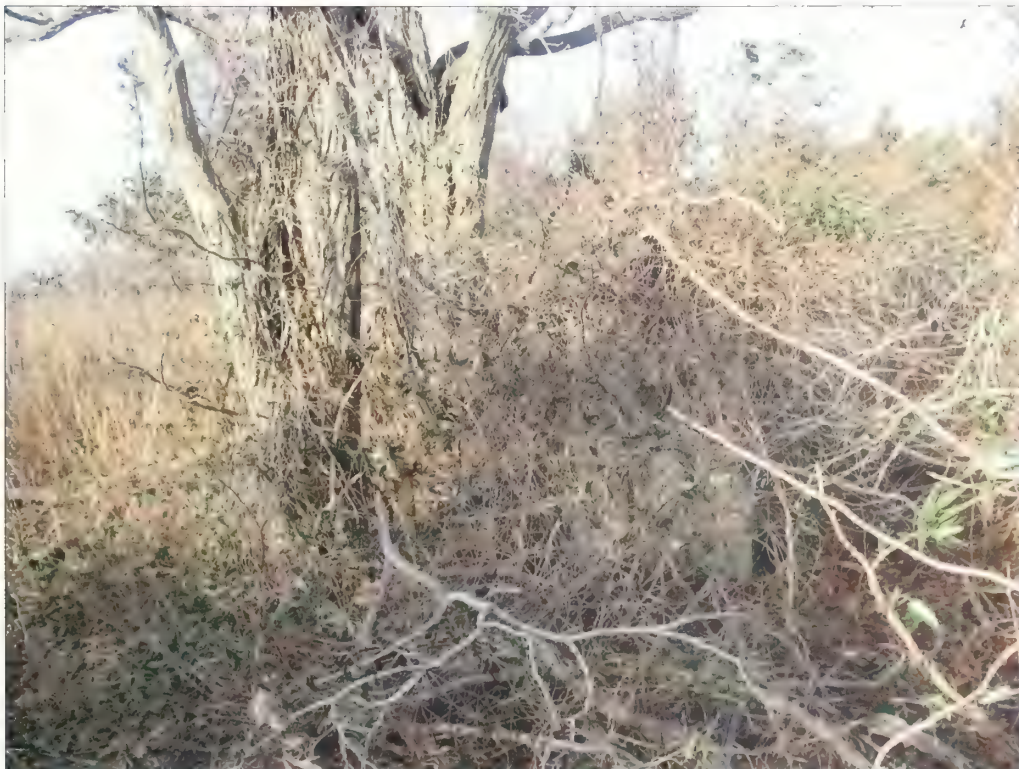
Figure 3.50. View looking north from the top of Battery Kingman. A concrete box, engulfed by Japanese honeysuckle (*Lonicera japonica*), is located south of emplacement #2 on the top of the engineered earthwork (Olmsted Center, January 2009).

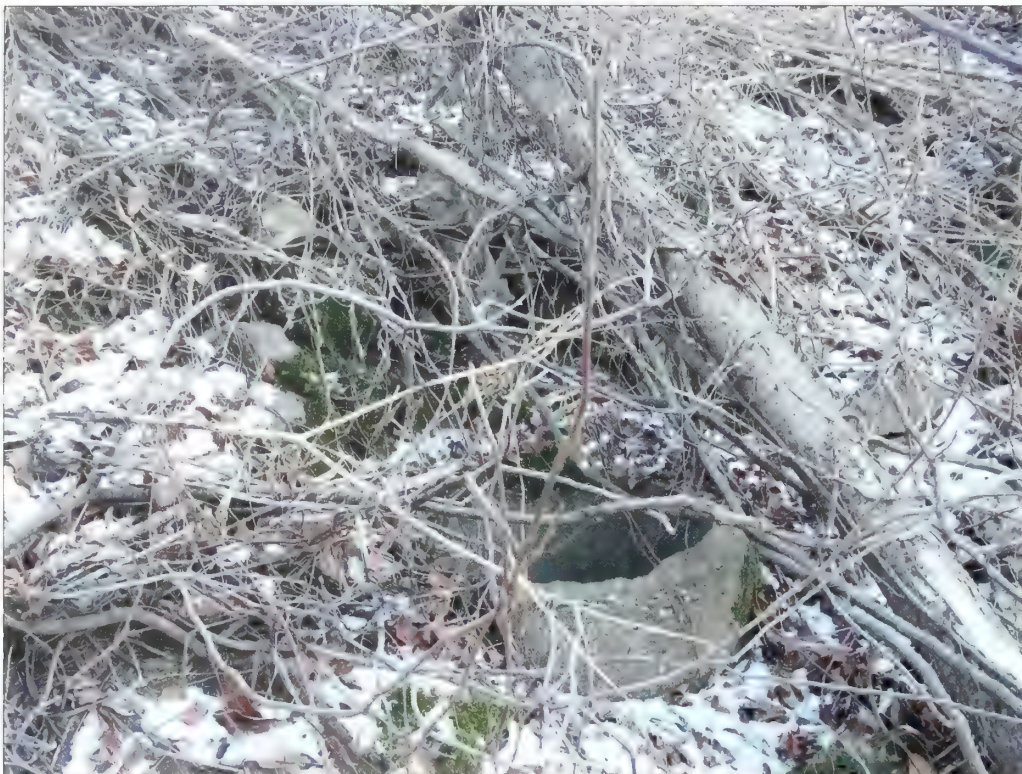
Figure 3.51. Concrete pipe, Battery Kingman. A concrete pipe protrudes through the engineered earthwork northwest of emplacement #2 (Olmsted Center, January 2009).

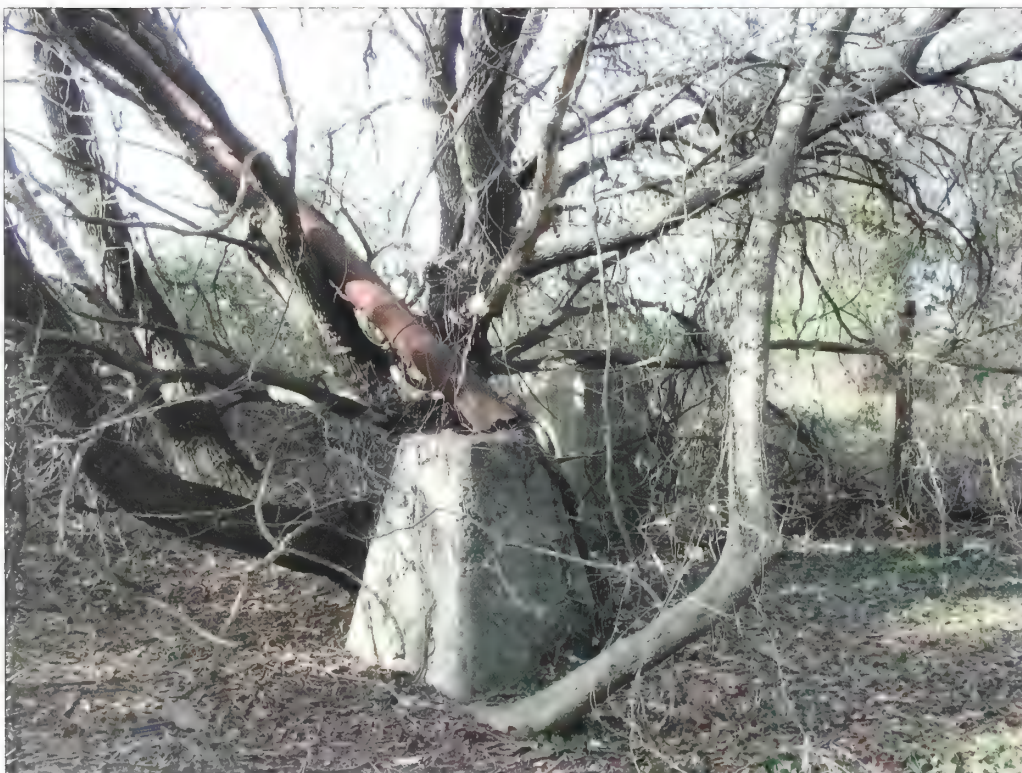
Figure 3.52. View looking northwest from the top of Battery Mills. A tapered concrete box and metal pipe are located near the center top of the engineered earthwork. These structures are most likely associated with ventilation or served as flues for furnaces (Olmsted Center, January 2009).

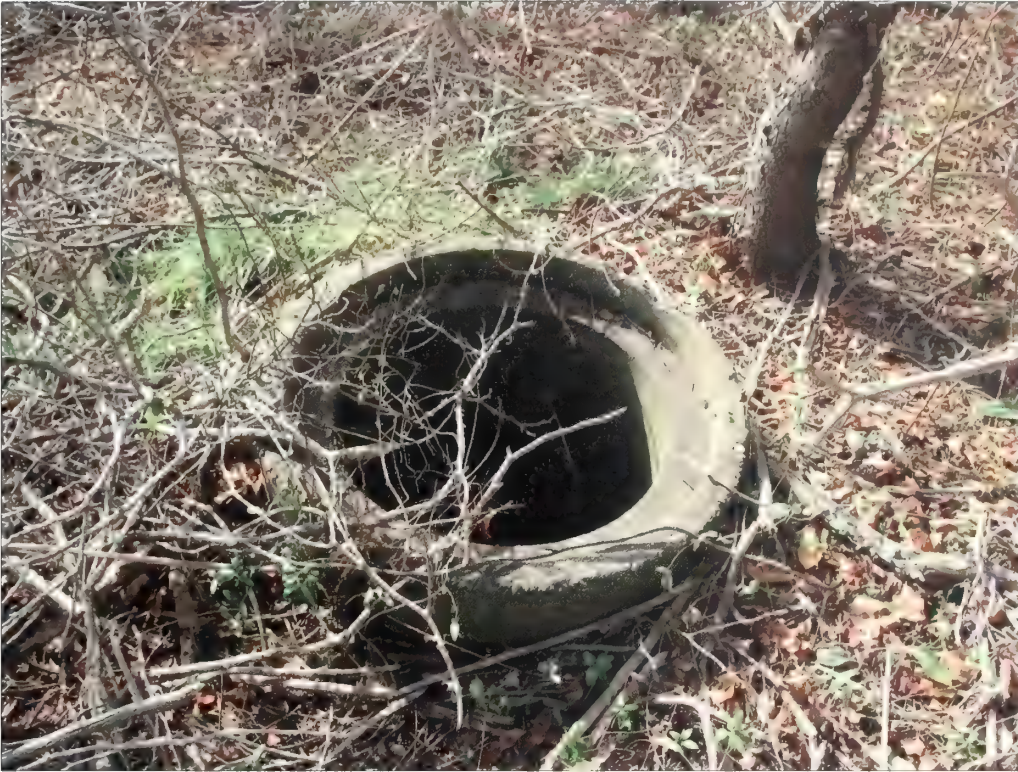
Figure 3.53. Concrete pipe, Battery Mills. Southwest of emplacement #1, a concrete pipe emerges from the engineered earthwork (Olmsted Center, January 2009).

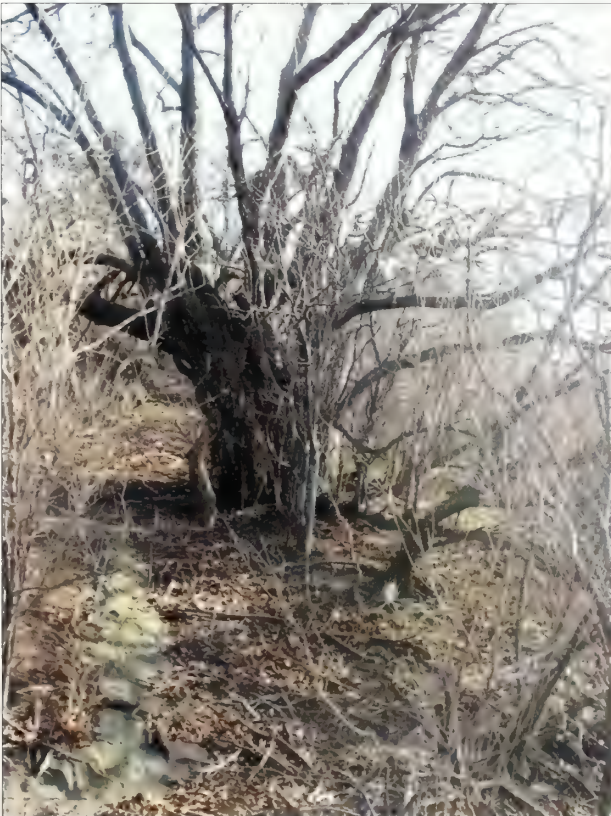
Figure 3.54. View looking south from the top of Battery Kingman. On the west side of Battery Kingman, a strip of concrete is exposed near the top of the earthwork and is possibly a piece of the reinforced concrete buster course installed to protect the battery from aerial bombing (Olmsted Center, January 2009).

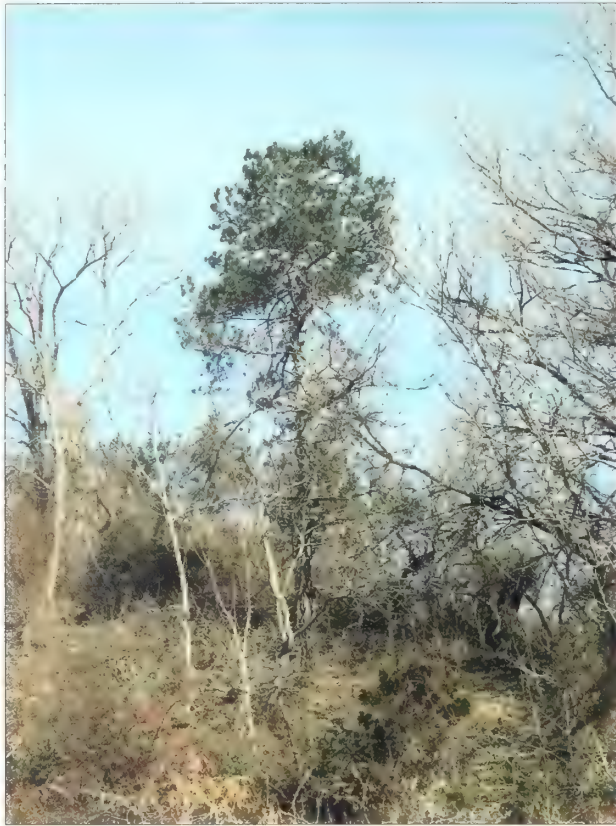
Figure 3.55. Scrub pine south of emplacement #1, Battery Mills. A few scrub pine (*Pinus virginiana*) were observed on the engineered earthwork that primarily contained mature eastern red cedar (*Juniperus virginiana*), hackberry (*Celtis occidentalis*), and ailanthus (*Ailanthus altissima*) (Olmsted Center, January 2009).

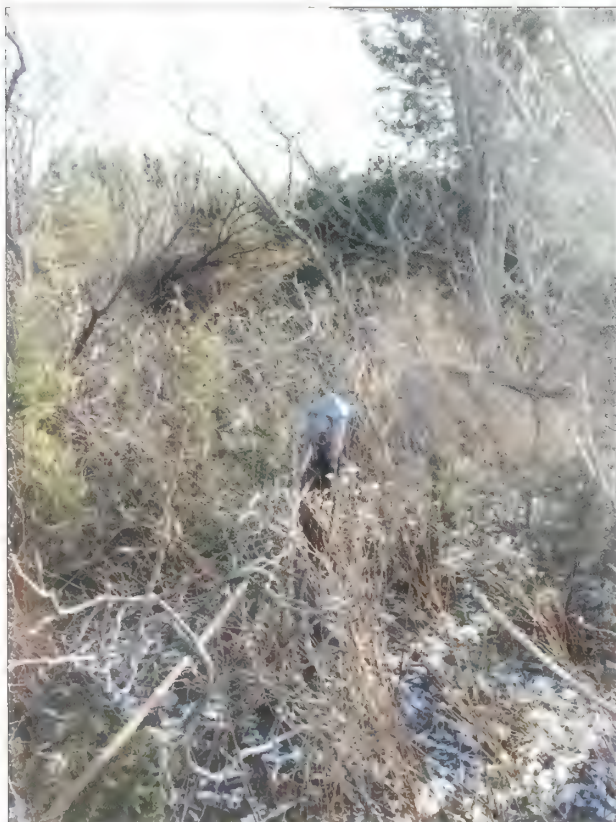
Figure 3.56. Post and wire fence, Battery Kingman. Near the high point above Battery Kingman's emplacement #2, a post and wire fence is installed that is overrun by vines and other vegetation (Olmsted Center, January 2009).

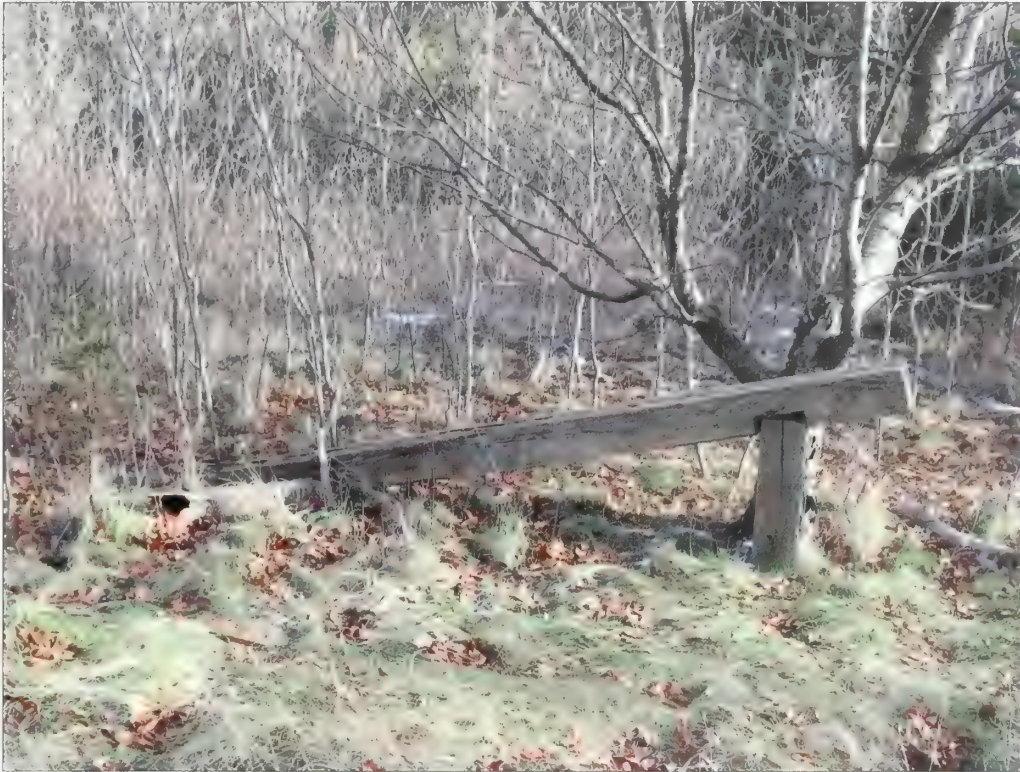
Figure 3.57. View looking east at collapsed wood guardrail, Battery Kingman. Across from both gun emplacements, a series of wood guardrails are installed along the eastern edge of the unpaved road. The guardrails are in fair to poor condition (Olmsted Center, January 2009).

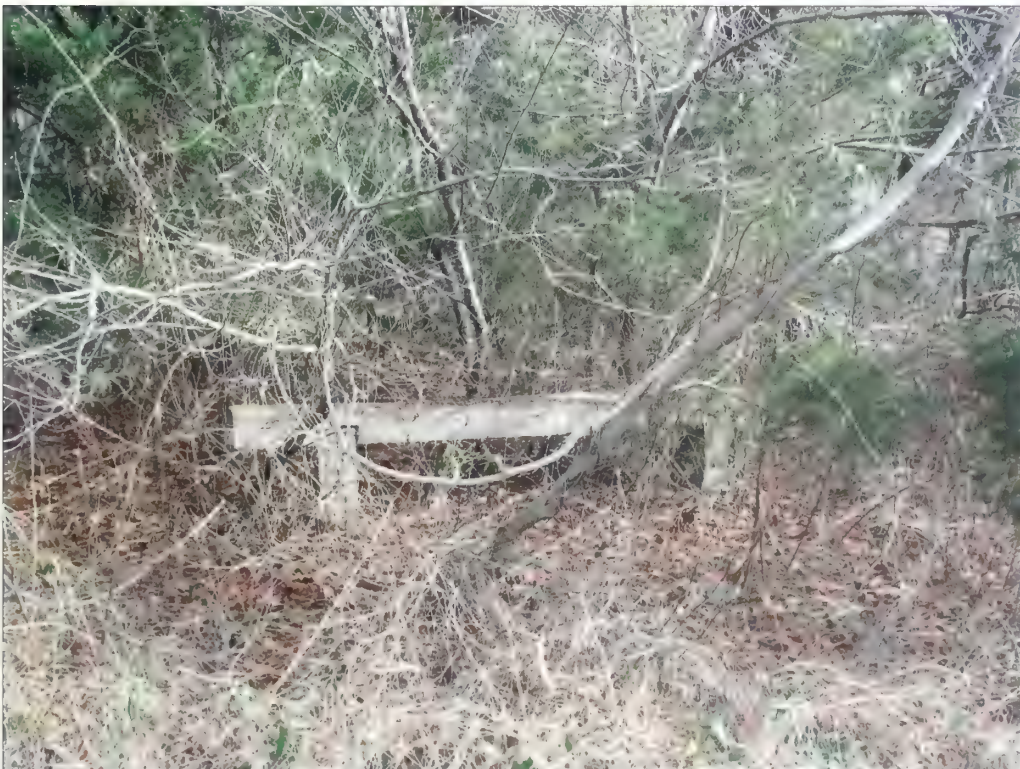
Figure 3.58. View looking east at wood guardrail, Battery Mills. Two series of wood guardrails are installed along the eastern edge of the unpaved road. The guardrails are in fair to poor condition and located across from the gun emplacements (Olmsted Center, January 2009).

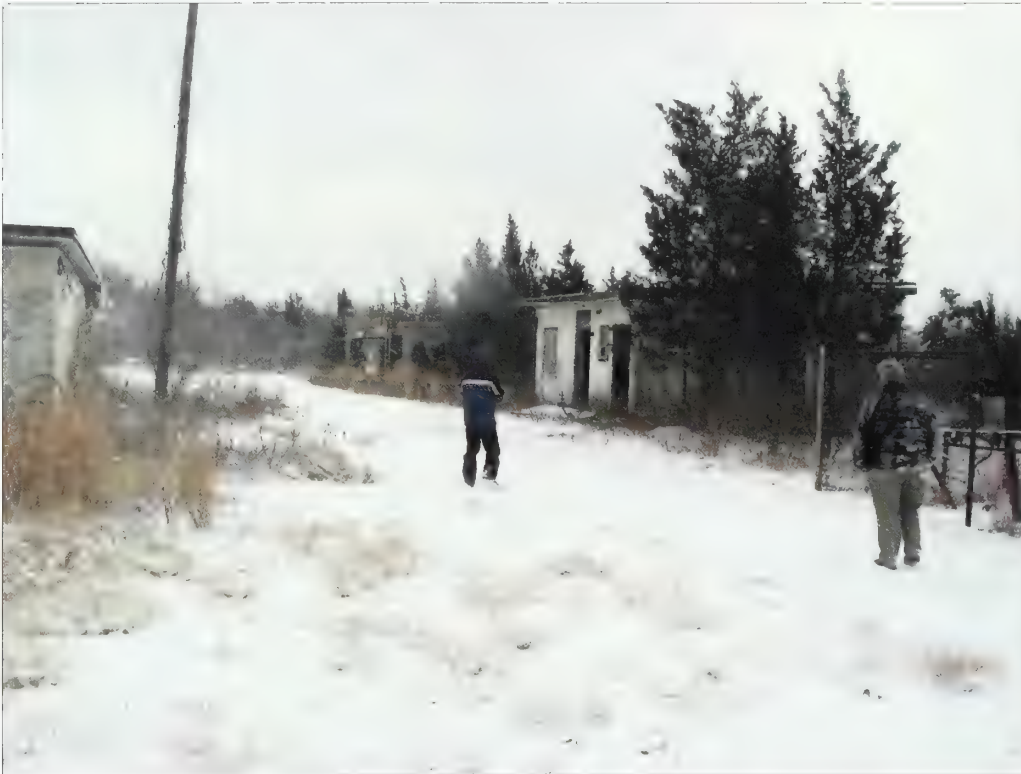
District. Pedestrian access from either the parking lot or the MUP is controlled by a locked gate that is part of the perimeter fence. Inside the radar site, a paved vehicular road connects Control Areas #1 and #2. From each control area, a vehicular route leads to the Ready Barracks (Figure 3.59). From Control Area #1, the route is paved and ends in a hammerhead turnaround. From Control Area #2, the route is unpaved and terminates west of the barracks in an irregularly-shaped parking area. The parking area contains loose stockpiles of bricks and other construction materials. A concrete sidewalk between each control area and the Ready Barracks provides pedestrian access between the locations (Figure 3.60).

Figure 3.59. View looking southeast from vehicular route to Control Area #1, NIKE radar site. From each control area, a vehicular route leads to the Ready Barracks. From Control Area #1, the route is paved and ends in a hammerhead turnaround south of the Ready Barracks (Olmsted Center, January 2009).

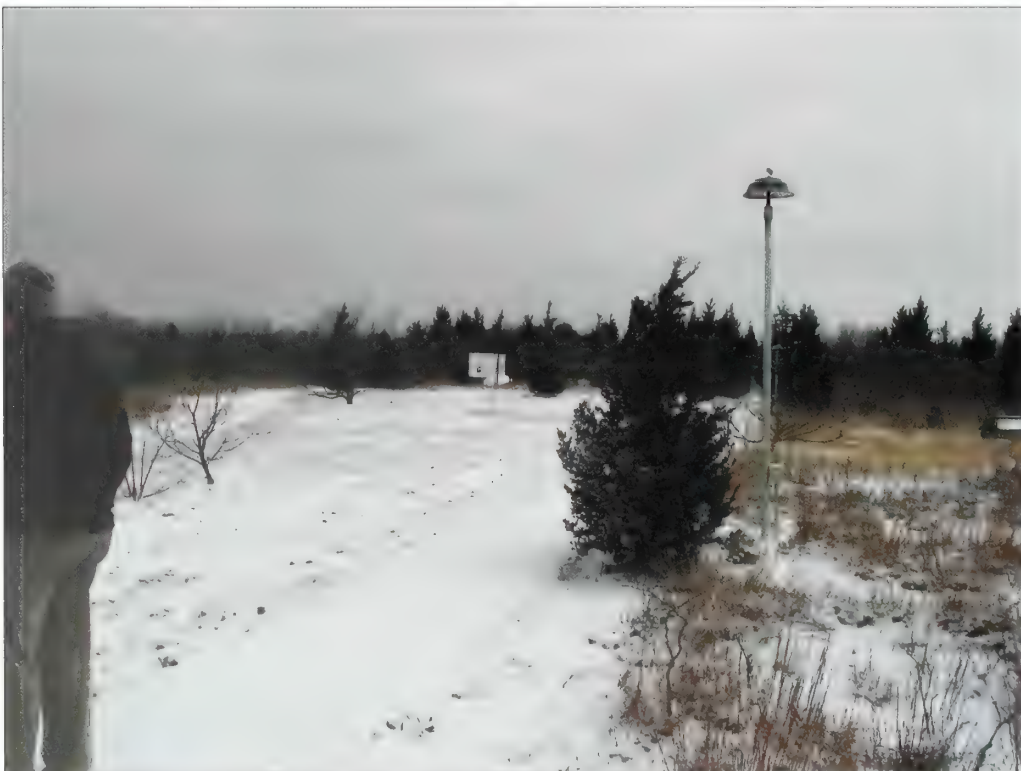
Figure 3.60. View looking north at walkway, Control Area #2, NIKE radar site. A concrete sidewalk between each control area and the Ready Barracks provides pedestrian access between the locations (Olmsted Center, January 2009).

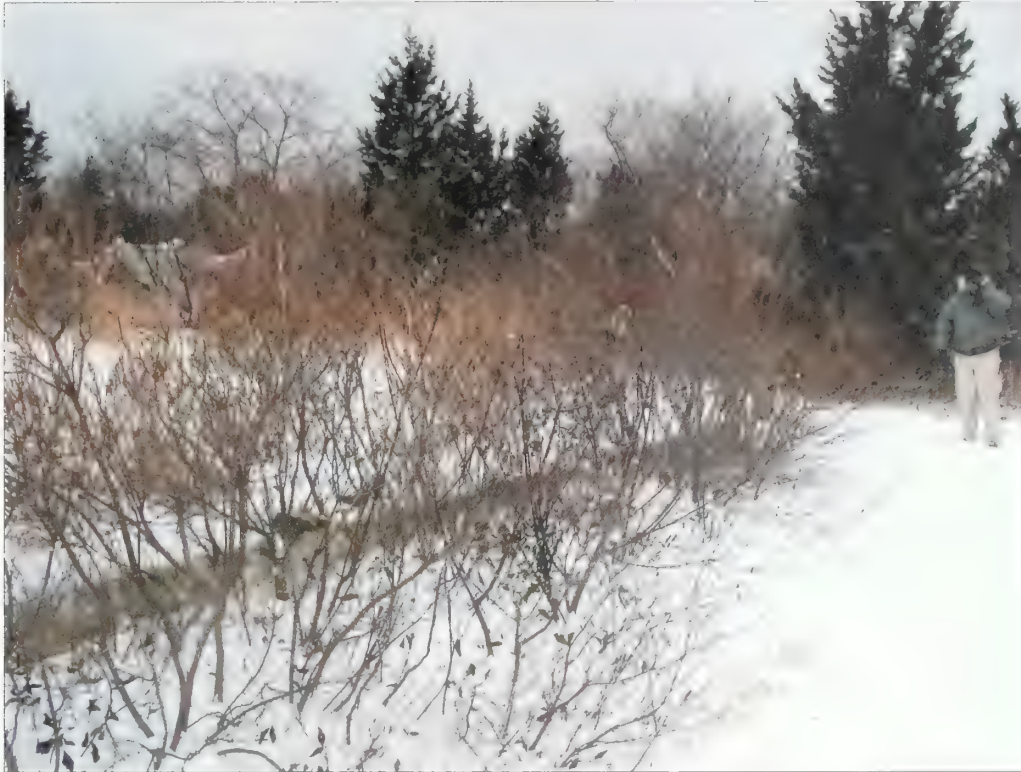
Figure 3.61. View looking north at HIPAR foundation, NIKE radar site. The foundation is obscured by shrub species such as bayberry (*Myrica* sp.) seen in the foreground (Olmsted Center, January 2009).

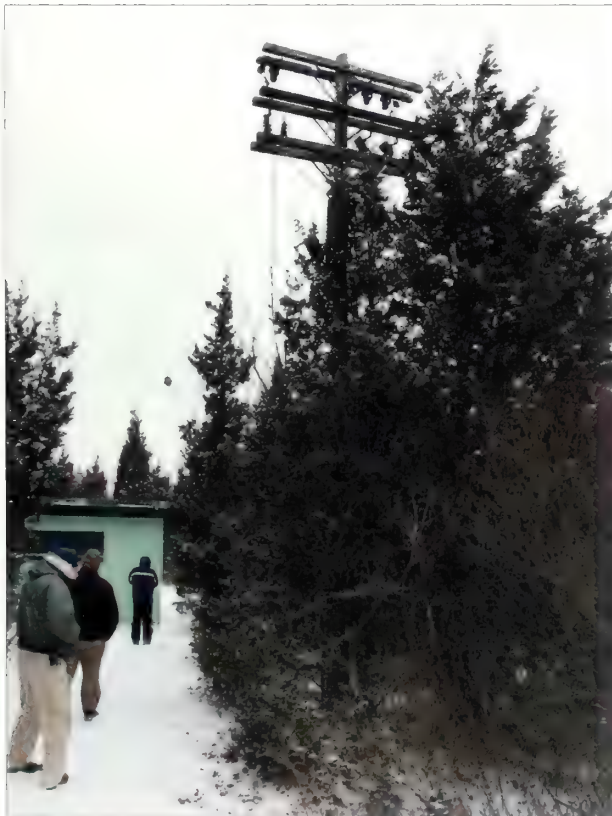
Figure 3.62. View looking north along walkway to Ready Barracks, NIKE radar site. The eastern red cedars (*Juniperus virginiana*) are immediately adjacent to and encroaching on the walkway (Olmsted Center, January 2009).

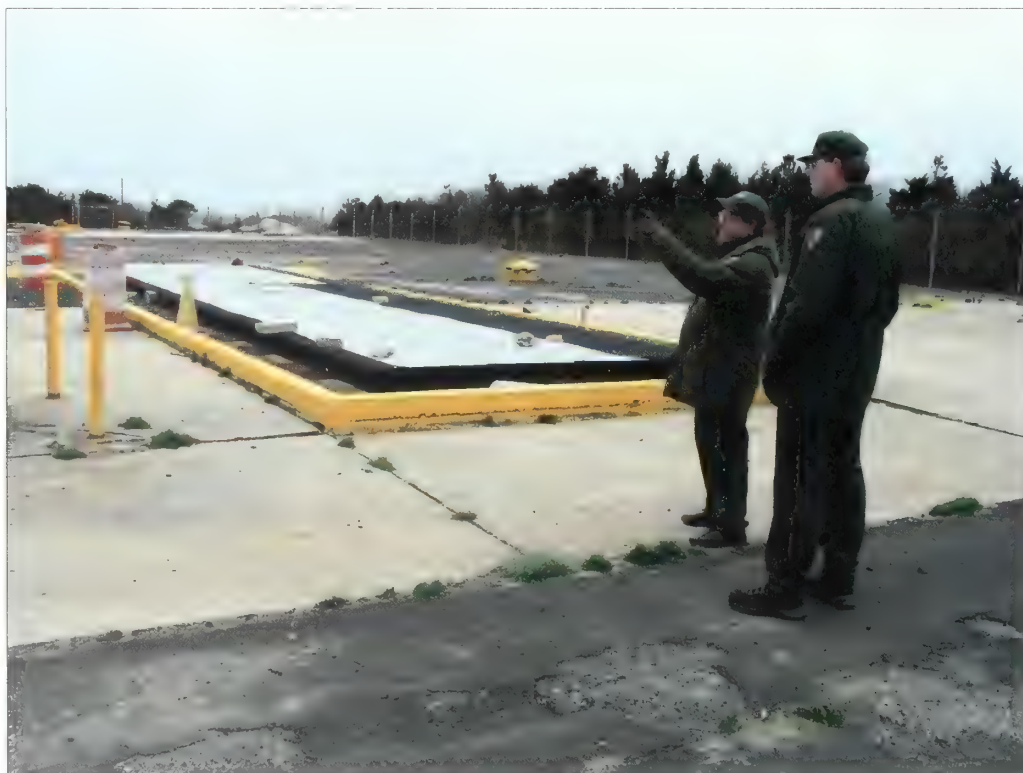
Figure 3.64. View looking west at elevator to missile magazine (425), NIKÉ launch site. The northern section of the launch site contains the underground missile magazines and concrete pads for launching racks. The concrete pads are oriented north to south for firing missiles to the east (Olmsted Center, April 2008).

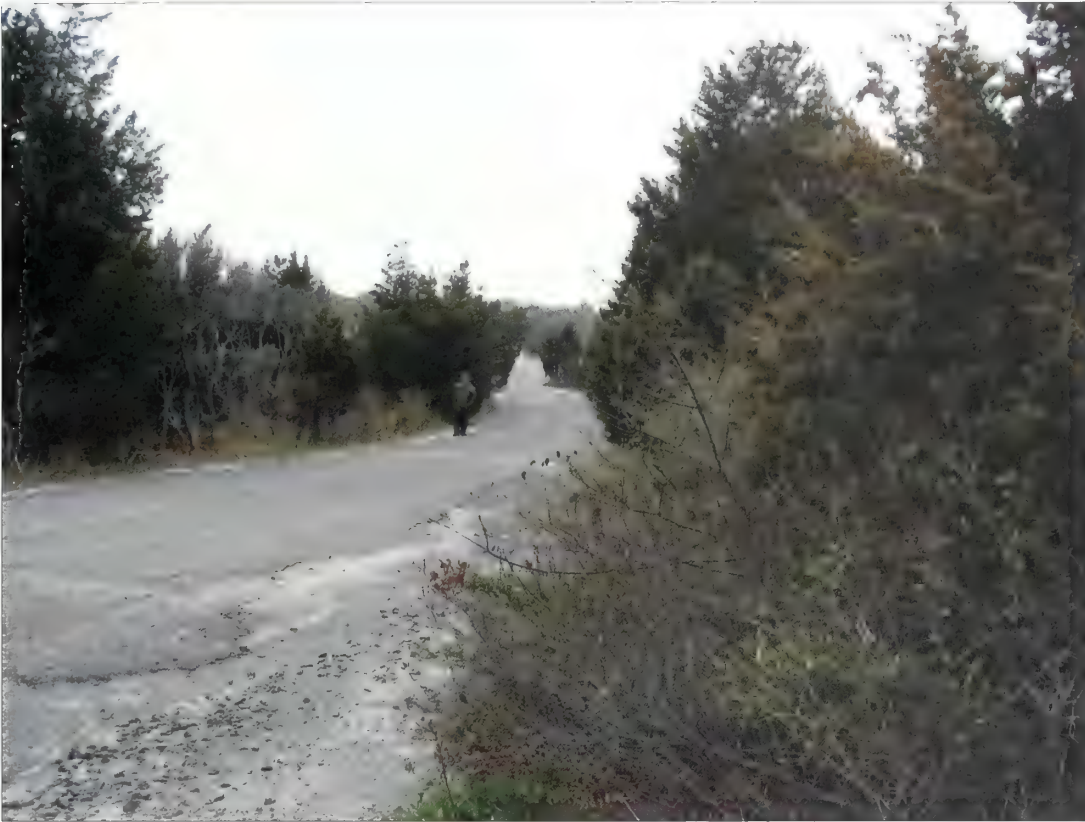
Figure 3.65. View looking west along central access road, NIKE launch site. Heading east from the Ready Barracks, the topography rises along the central access road to the missile magazines (Olmsted Center, April 2008).

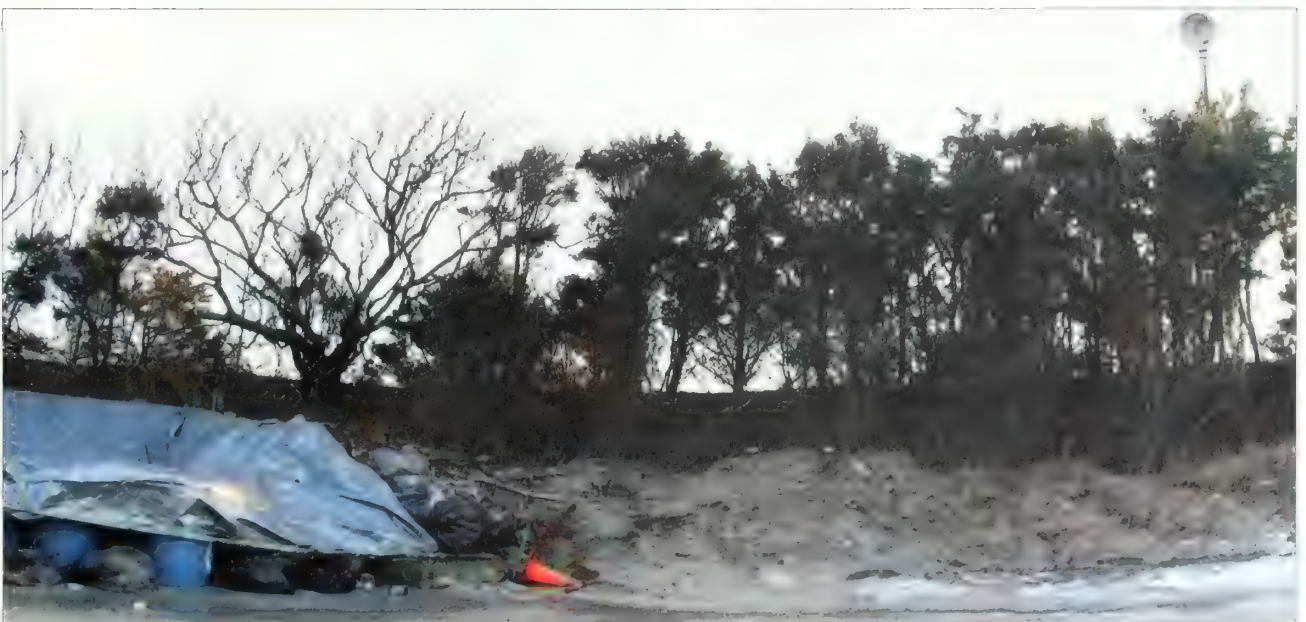
Figure 3.66. View looking south at engineered earthwork, NIKE launch site. South of the Warhead Building, a crescent-shaped earthwork rises to an elevation of twenty feet. The tips of the crescent wrap around the Warhead Building to the north and almost form a continuous landform with a northern earthwork (Olmsted Center, January 2009).

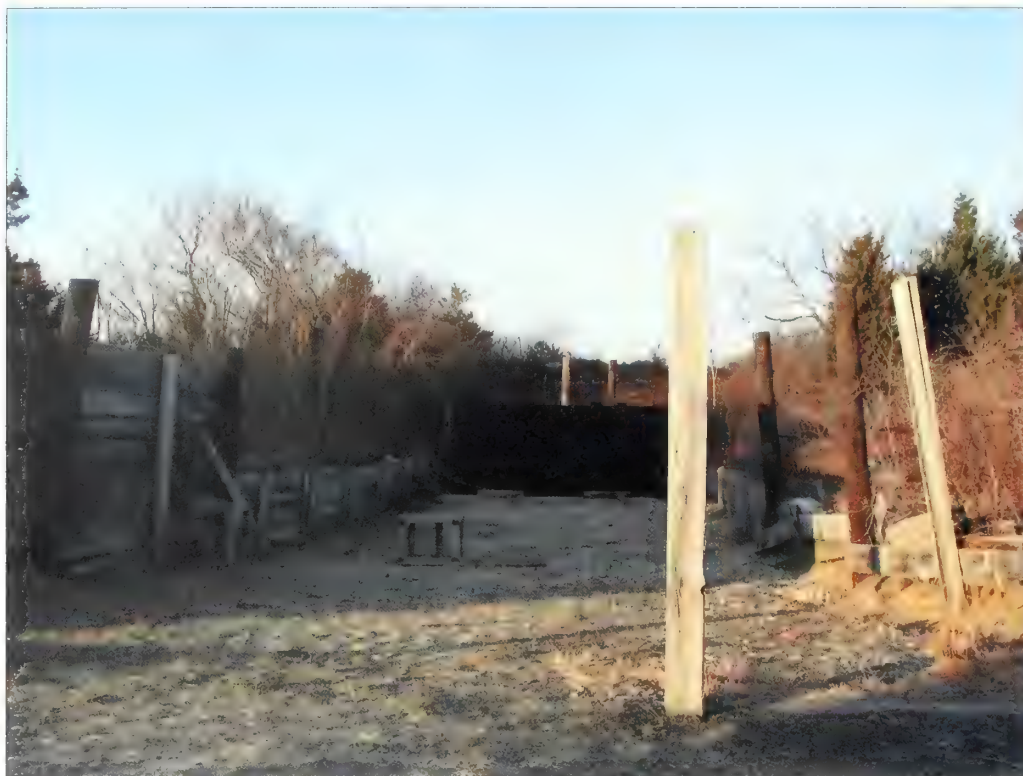
Figure 3.67. View looking north at firearms range, NIKE launch site. North of the Warhead Building, park law enforcement has set up a firearms range in a low lying area. The land rising around the depression acts as a backstop for the range (Olmsted Center, January 2009).

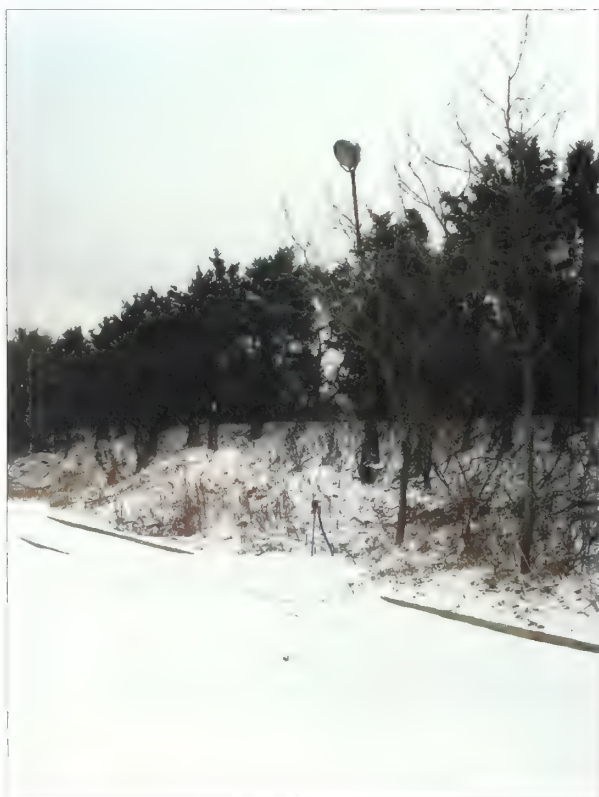
At the NIKE launch site, vegetation primarily consists of eastern red cedars (*Juniperus virginiana*), shrub species such as bayberry (*Myrica* sp.) and sumac (*Rhus* sp.), and grass species. Eastern red cedars cover the majority of the engineered earthworks in the Missile Maintenance Area (Figure 3.68). A mixture of vegetation encroaches on buildings, vehicular and pedestrian circulation features, and the perimeter fence. In many cases, vegetation is immediately adjacent to a building or feature.

Figure 3.68. View looking southeast at engineered earthwork, NIKE launch site. Eastern red cedars (*Juniperus virginiana*) cover the majority of the engineered earthworks in the Missile Maintenance Area (Olmsted Center, January 2009).

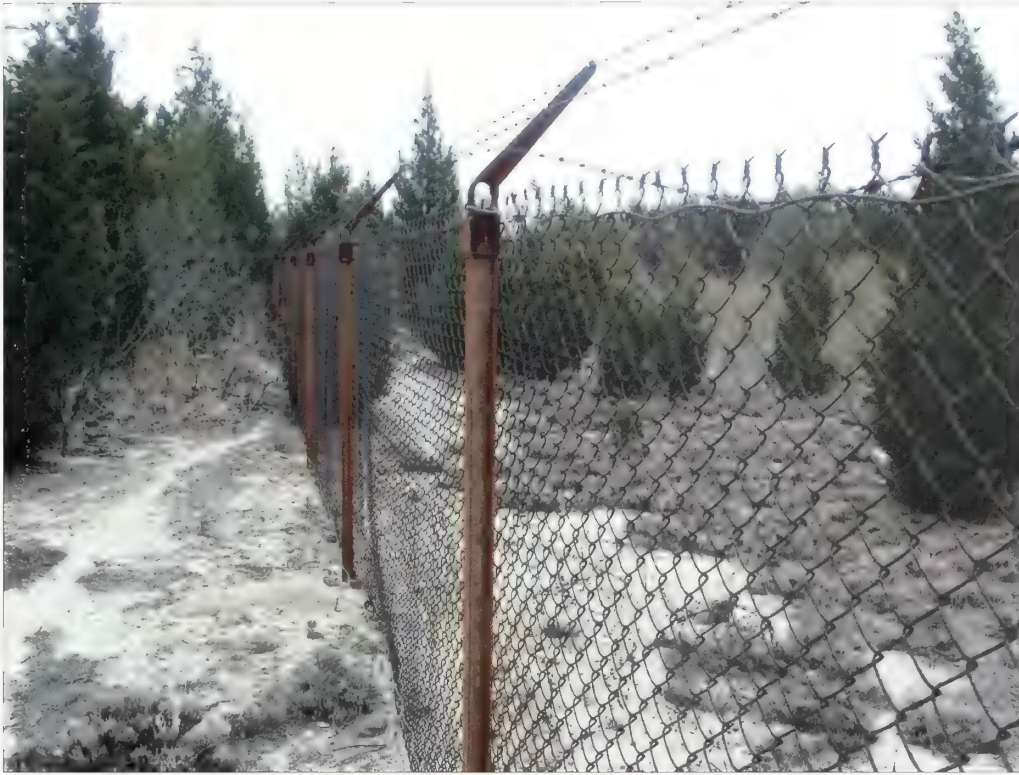
Small-scale features at the NIKE launch site include an inner and outer security fence, floodlights along the inner security fence, floodlights at the Missile Maintenance Area, spotlights in the Missile Magazine area, two antenna, and a missile display erected on the road in the Ready Barracks. Similar to the radar site, the launch site features a perimeter fence along its outside boundary and then adds an inner fence that encloses the missile magazines. Both fences are comprised of chain-link sections secured to H-shaped posts. The top of each post holds a single extension arm that supports strands of barbed wire. The inner and outer fences are in fair to poor condition and beach erosion has undermined portions of the outer fence near the northeast corner of the site (Figures 3.69 and 3.70).

Figure 3.69. Outer fence, NIKE launch site. The launch site features a perimeter fence along its outside boundary and then adds an inner fence that encloses the missile magazines. This section of fence is in fair condition (Olmsted Center, April 2008).

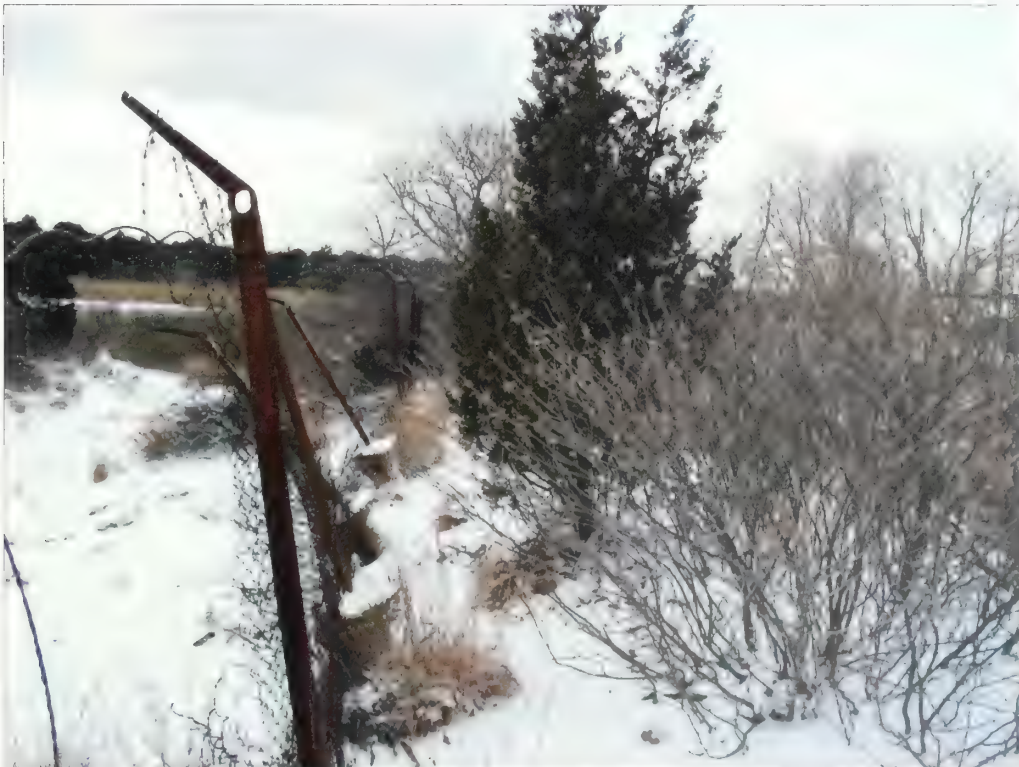
Figure 3.70. Outer fence, NIKE launch site. The inner and outer fences are comprised of chain-link sections secured to H-shaped posts. The top of each post holds a single extension arm that supports strands of barbed wire. This section of fence is in poor condition (Olmsted Center, January 2009).

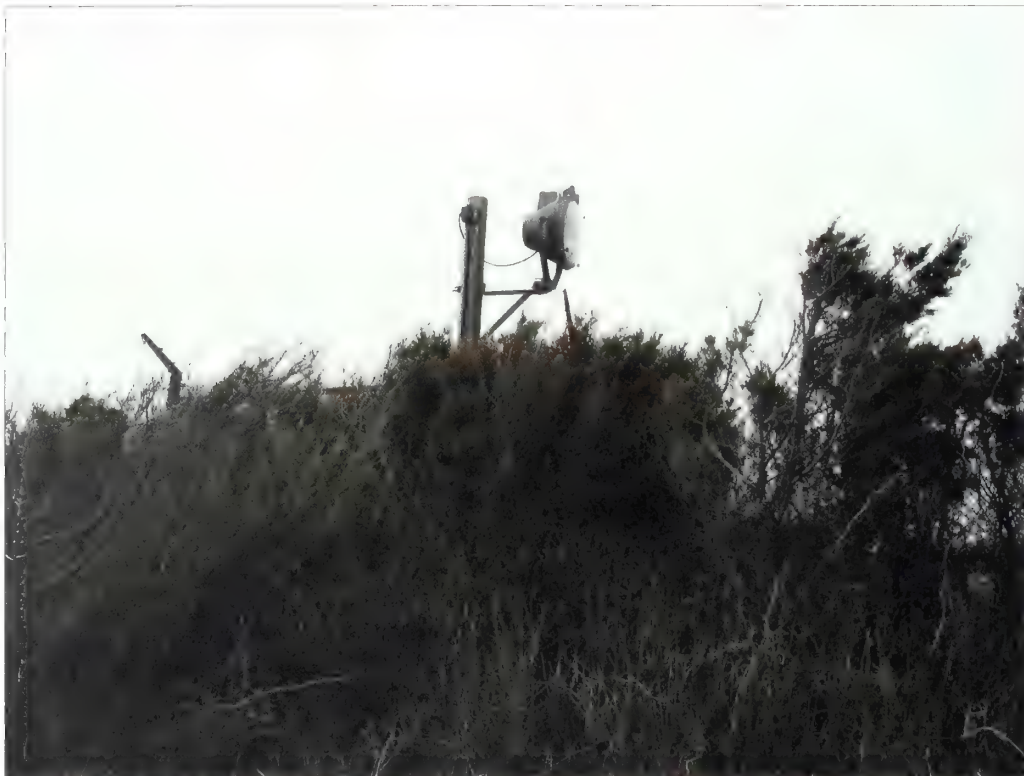
At the Missile Magazine area, eight floodlights are positioned along the inner fence. Each light features a parabolic fixture mounted with a metal bracket to a round, wood pole (Figure 3.71). The fixtures are aimed parallel to the direction

Figure 3.71. Floodlight, NIKE launch site. At the Missile Magazine area, eight floodlights are positioned along the inner fence. Each light features a parabolic fixture mounted with a metal bracket to a wood pole. Six similar lights are located at the Missile Maintenance Area on the engineered earthworks (Olmsted Center, April 2008).

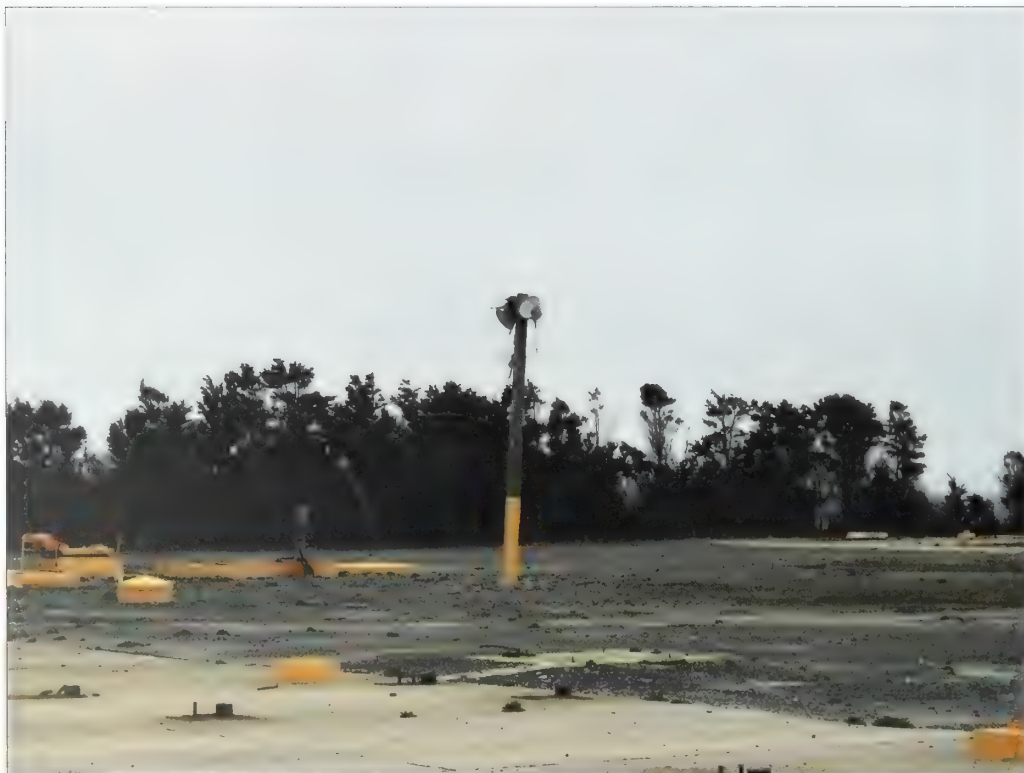
of the inner fence. Six similar lights are located at the Missile Maintenance Area with half located on the northern engineered earthwork and the other half on the southern engineered earthwork. The six lights are mounted at the top of round, metal poles. Vegetation encroaches on many of the floodlights, however, they are in good to fair condition. In the Missile Magazine area a single, round, wood pole stands near the Section B magazine (427). From ground level, the first eight to ten feet of the pole are painted yellow and a red "B" is featured on the yellow field. Two spotlights with parabolic metal hoods are mounted at the top of the pole (Figure 3.72).

Figure 3.72. Spotlights, NIKE launch site. In the Missile Magazine area a single, round, wood pole stands near the Section B magazine (427). The first eight to ten feet of the pole are painted yellow and two spotlights with parabolic metal hoods are mounted at the top of the pole (Olmsted Center, April 2008).

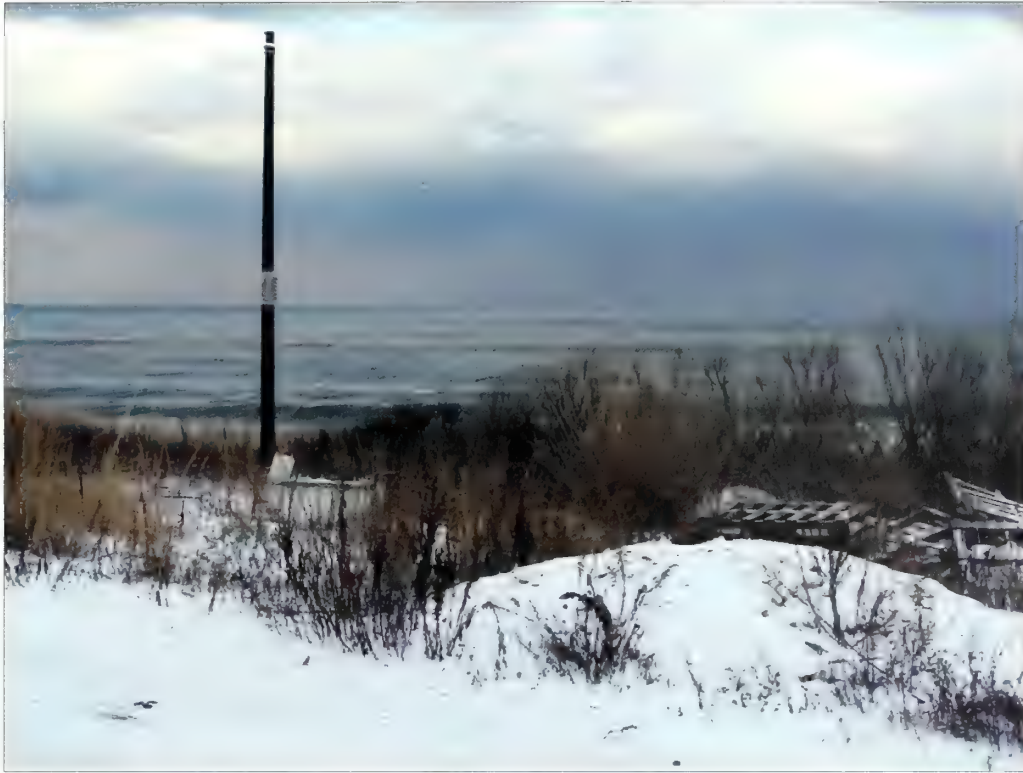
East of the Missile Maintenance Area and approaching the outer fence, an antenna and monitoring equipment have been set up for collecting weather and tide information (Figure 3.73). A second antenna assists with collecting weather and tide information and is located south of the Missile Maintenance Area near the outer fence (Figure 3.74). In the southwest corner of the Ready Barracks, a missile display has been installed on the road connecting the central access road to the barracks' Latrine (434). The display informs visitors about the weaponry used at Sandy Hook's last generation of coastal defenses.

Figure 3.73. View looking east at antenna, NIKE launch site. East of the Missile Maintenance Area and approaching the outer fence, an antenna and monitoring equipment have been set up for collecting weather and tide information (Olmsted Center, January 2009).

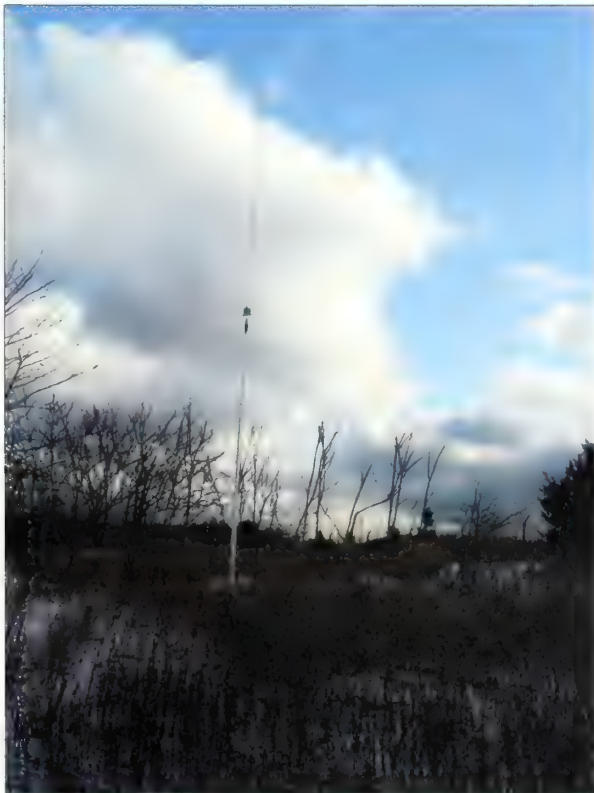
Figure 3.74. View looking northeast at antenna, NIKE launch site. A second antenna assists with collecting weather and tide information and is located south of the Missile Maintenance Area near the outer fence (Olmsted Center, January 2009).

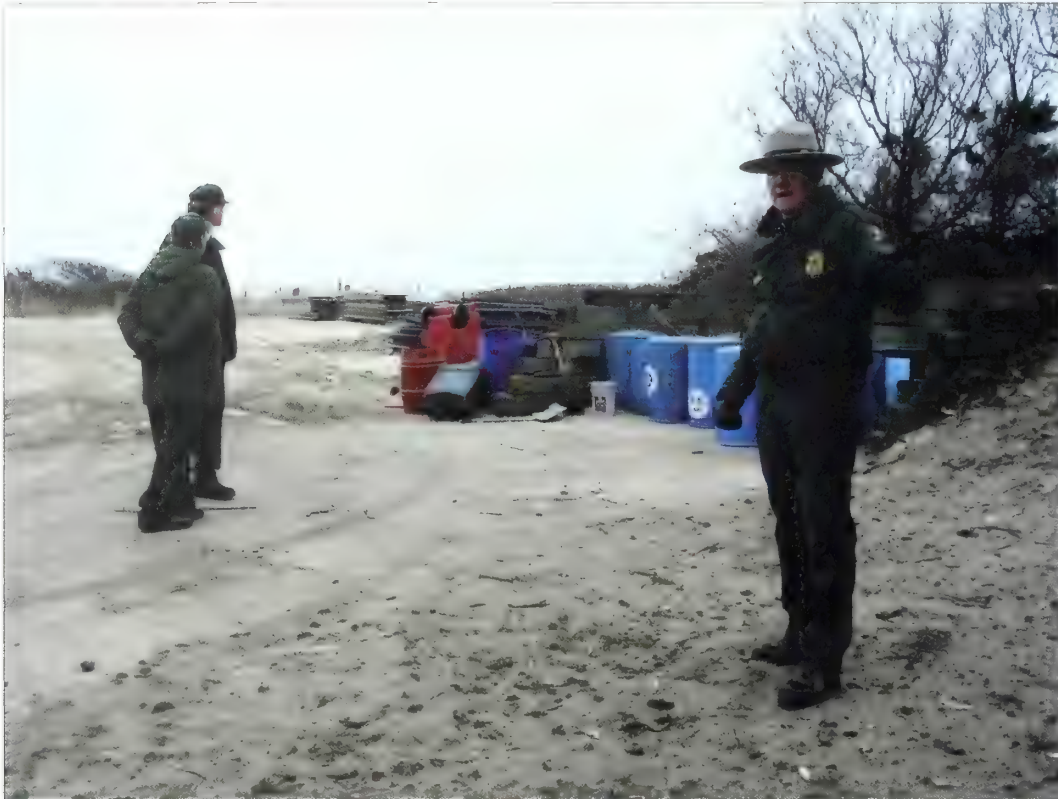
Existing Condition: The engineered earthworks are primarily intact with some erosion occurring since the end of the historic period. At the NIKE launch site, recycling bins cut into a portion of the south earthwork at the Missile Maintenance Area (Figure 4.2). For all sites, social trails across the earthworks advance erosion and threaten these features (see Figure 3.11). Large woody vegetation growing on the earthworks creates the potential for the placed earth and sand to be removed by a toppled tree.

Figure 4.2. View looking east at the south earthwork, Missile Maintenance Area, NIKE launch site. The railroad tie retaining structure and recycling containers cut into a portion of the engineered earthwork (Olmsted Center, April 2008).

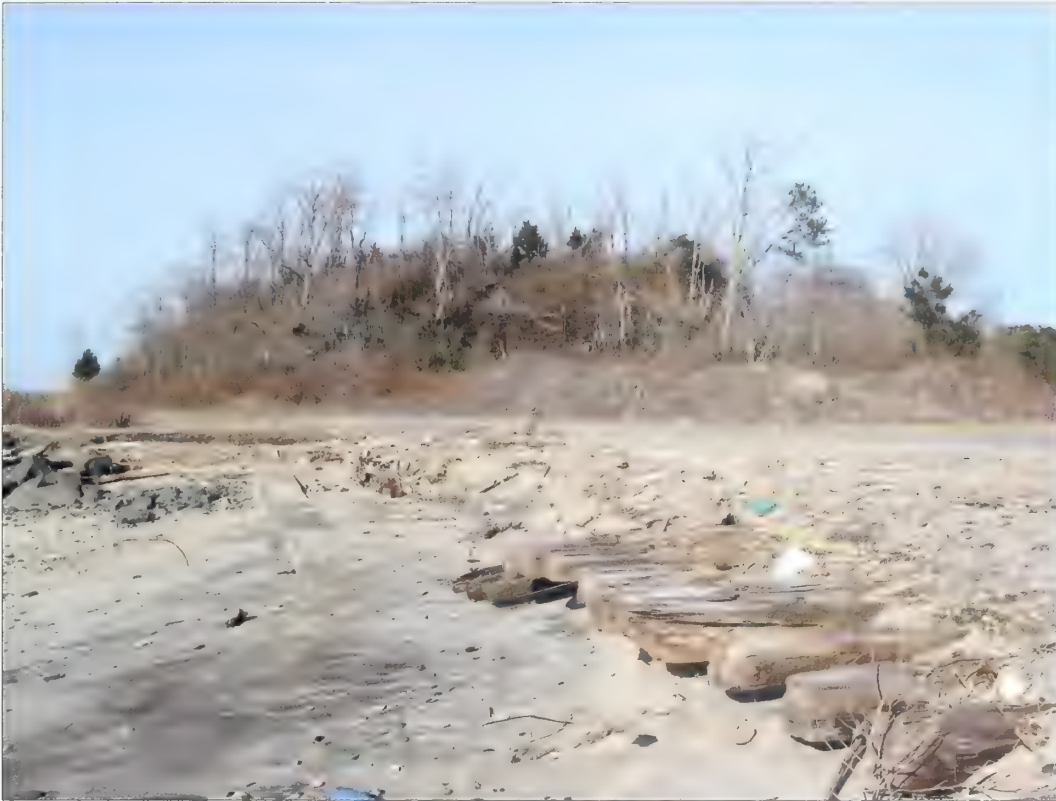
Figure 4.4. View looking northwest at Battery Kingman. South of Battery Kingman, coastal erosion has exposed wooden railroad ties. The ties are remnants of a railroad system that delivered ammunition to the coastal defense batteries throughout Sandy Hook. After this picture was taken, continuing coastal erosion completely removed the railroad ties (Olmsted Center, January 2009).
